REPAIR, EVALUATION, MAINTENANCE, AND  
REHABILITATION RESEARCH PROGRAM

# CASE HISTORIES OF CORPS BREAKWATER AND JETTY STRUCTURES

Report 3

NORTH CENTRAL DIVISION

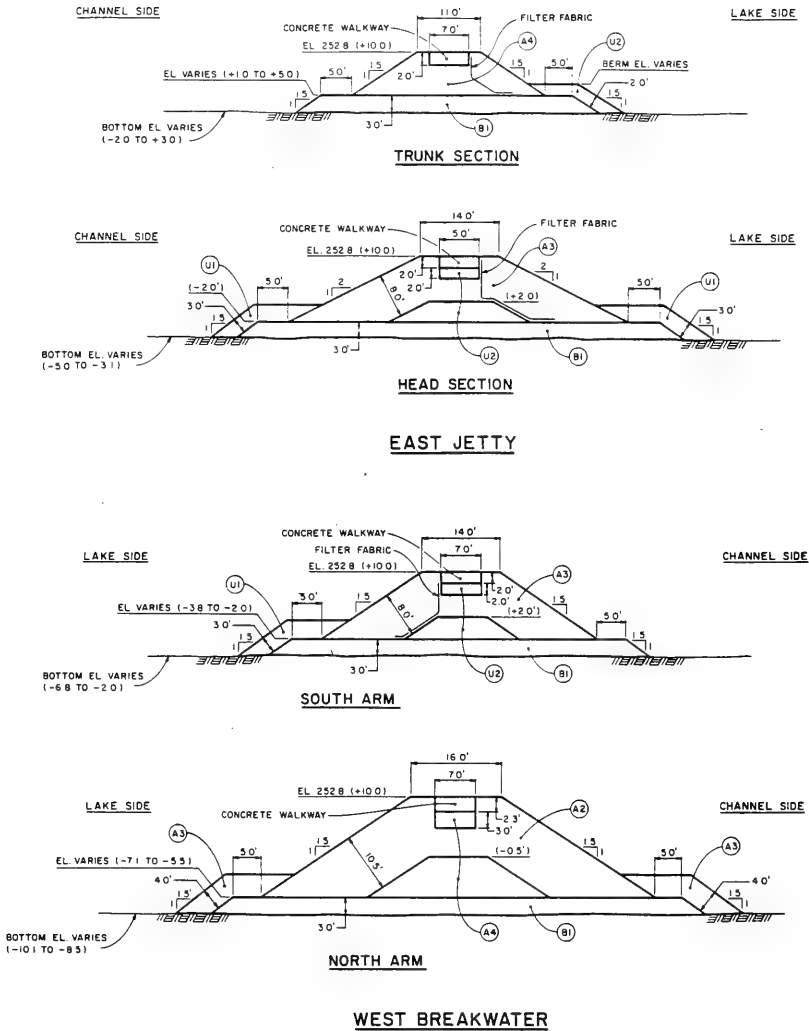
Figure 285. Typical structure cross sections, Irondequoit Bay, New York

**WEST BREAKWATER**

- A2 ARMOR STONE 7.0 TO 15.5 TONS
- A3 3.0 TO 6.5 TONS
- A4 0.5 TO 1.5 TONS
- B1 BEDDING MATERIAL 0 TO 15 IN.
- U1 UNDERLAYER STONE 1500 TO 5000 LBS.
- U2 400 TO 1300 LBS.

Date(s)	Construction and Rehabilitation History
1985	<p>Construction of a 1,350-ft-long west breakwater and a 750-ft-long east jetty (Figure 284) was completed. The structures were built of rubble-mound materials with crest elevations of +10 ft lwd (Figure 285). The trunk section of the east jetty had an 11-ft-wide crest width, 1-V:1.5-H side slopes, and 0.5- to 1.5-ton armor stone. The east jetty head section and the shoreward arm of the west breakwater had crest widths of 14 ft and armor stones ranging from 3.0 to 6.5 tons. The head section of the east jetty had side slopes of 1V:2H. The lakeward arm of the west breakwater included armor stone ranging from 7 to 15.5 tons and a crest width of 16 ft. Side slopes of the west breakwater were 1V:1.5H, with the exception of the head which had 1-V:2-H slopes. An aerial view of the Irondequoit Bay structures taken during construction is shown in Figure 286. (Note the channel had not been dredged.)</p>
